Waadookawaad Amikwag

Re: Requesting a REJECTION of Enbridge's Line 5 Tunnel Project Proposal

Enbridge Line 3 Construction Deep Water/Aquifer Breaches

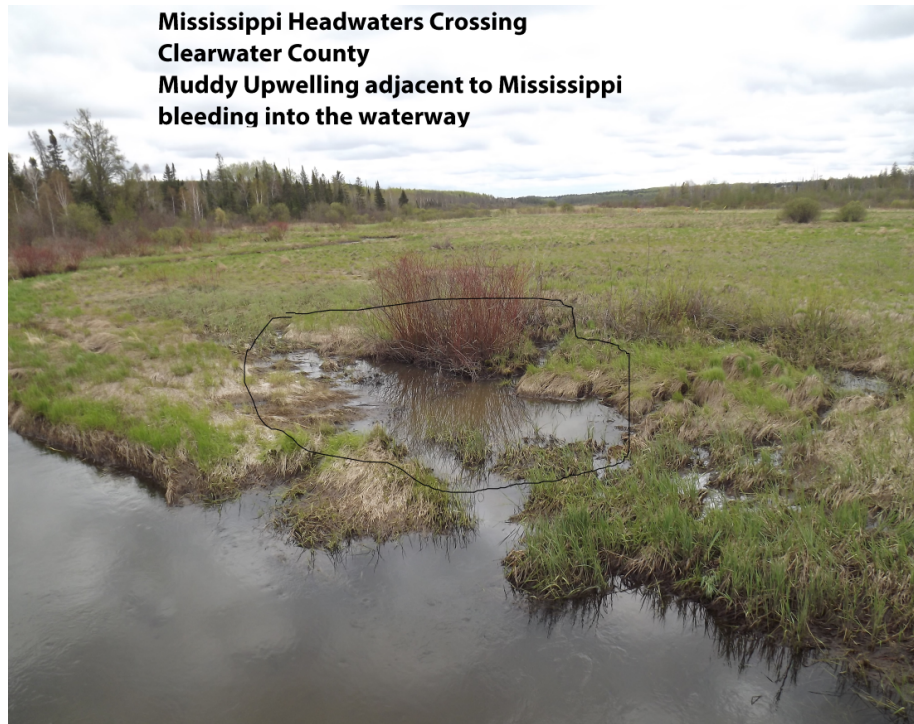
**Mississippi Headwaters Crossing
Clearwater County
Muddy Upwelling adjacent to Mississippi
bleeding into the waterway**

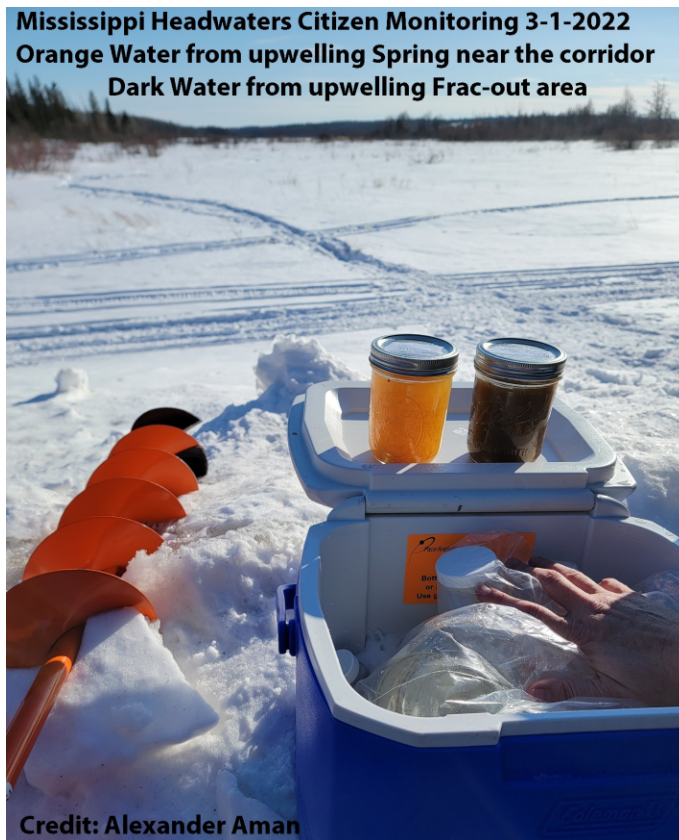
**Mississippi Headwaters Citizen Monitoring 3-1-2022
Orange Water from upwelling Spring near the corridor
Dark Water from upwelling Frac-out area**

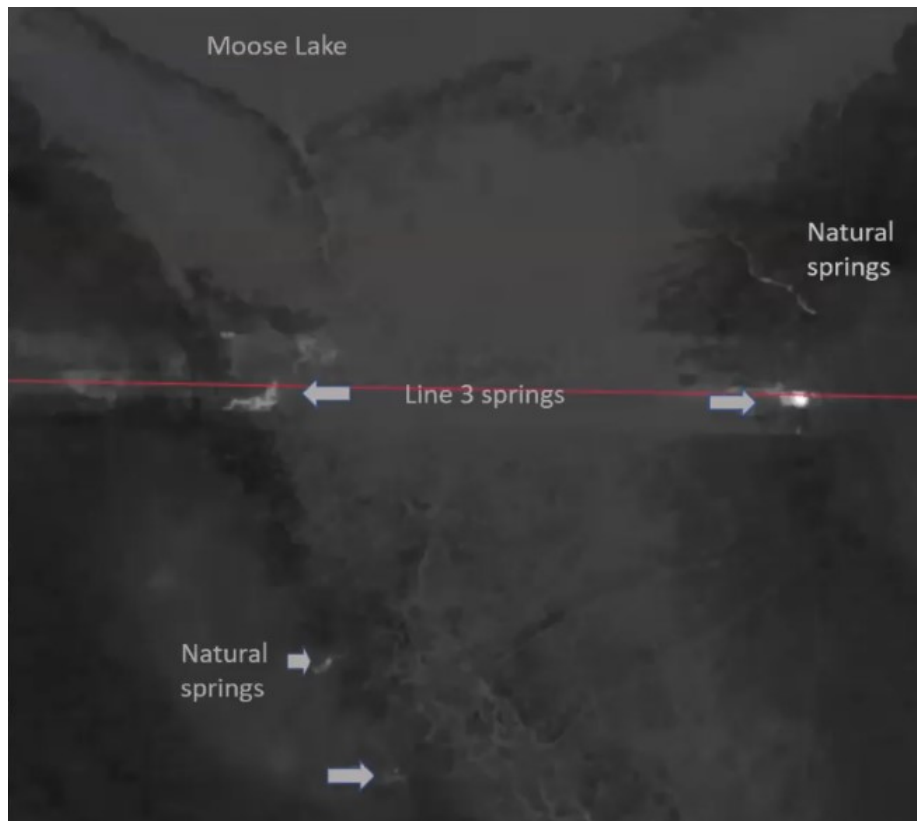
**Enbridge Aquifer Breach
near Fond du Lac Reserve
bleeding for over a year
since creation.**

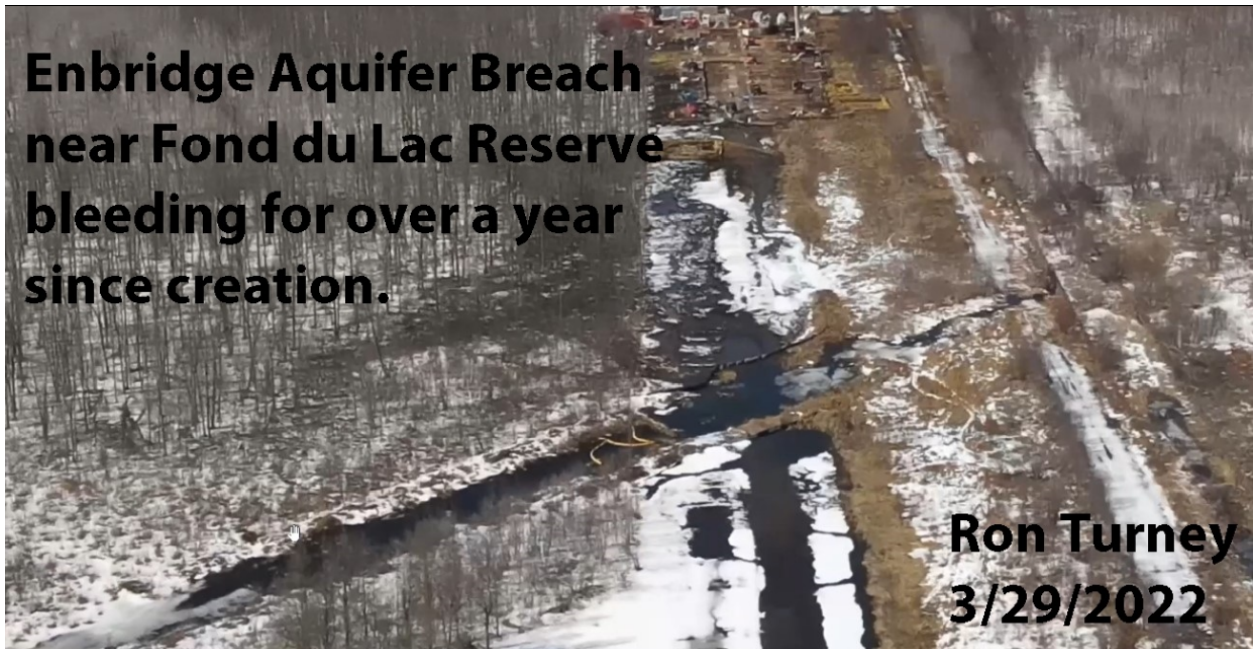
**Ron Turney
3/29/2022**

As you may remember from the late evening comments on September 8th at the Straits of Mackinac, we are including for you these photographs of the land, provided by [R.I.S.E. Coalition](#) and presented by Nookomis Deb Topping, Carrie Chesnik, Sherry Couture, and Jami Gaither. In addition, we include a new photograph taken on 8/25/22 in Walker Brook Valley, depicting our latest confirmed deep water breach by Enbridge, which was unavailable that evening.
